CRITIQUE SUMMARY

Critique No.: CH-BH-BNL-AGS-2000-0004

At 0050 on 10/4/00, a Collider-Accelerator Support (CAS) Watch entered Building 930 for a routine check of equipment running at Linac. He found a smoke-filled building and pulled a fire-alarm box. He went outside and noticed no alarms nor did the Fire Department respond. He went back into Linac Control Room in Building 930, a location where he noticed no smoke and called extension 911. The on-duty Fire/Rescue Officer told the CAS Watch to pull another fire-alarm box and to go out to the road to guide the responding unit. The CAS Watch pulled a box near the Linac Control Room and left the building. This pull box caused the discharge of the halon fire-protection system and activated local audible alarms, however this pull box also failed to alert the Fire Department. First-arriving Fire Department staff found a moderate smoke condition. They searched the facility but did not find the source of smoke. Linac personnel arriving at 0120 found a damaged Motor Control Center (MCC) with burned material in front of the MCC panels. The fire burned itself out, and the smoke was vented without incident. The area has a sprinkler protection

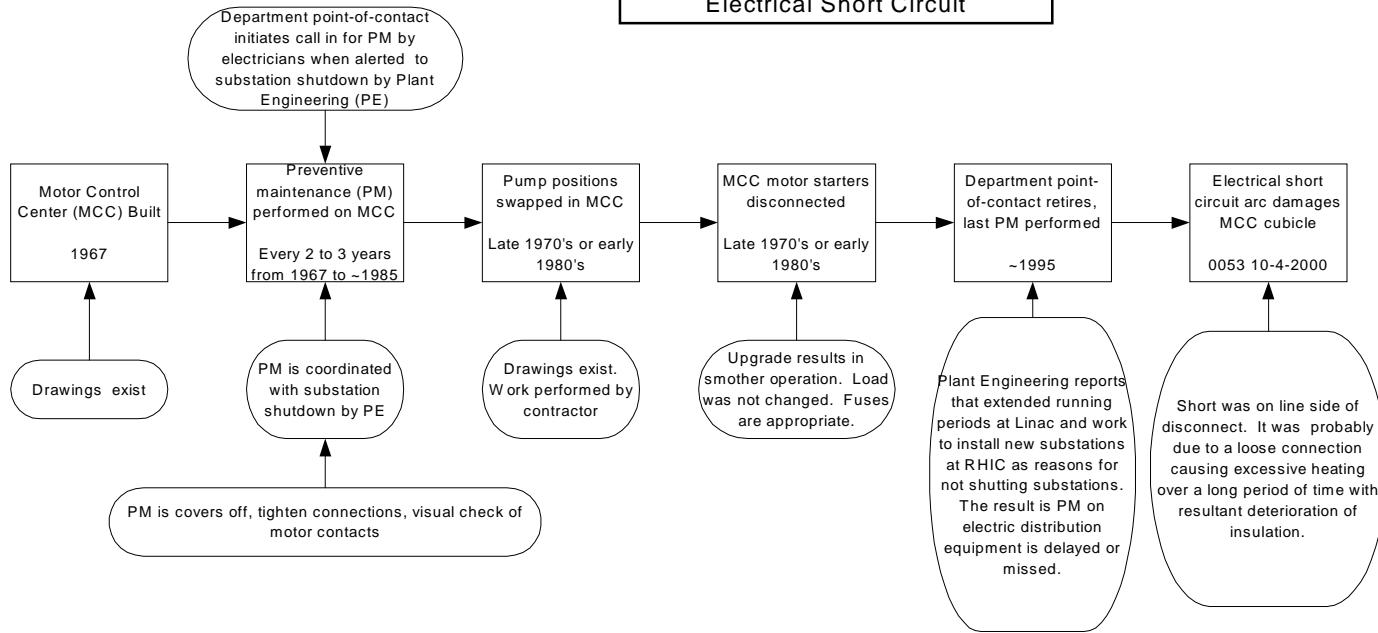
Electrical Short Circuit

The investigation showed an electric short on the line side of one of the MCC compartments, which triggered the following chain of events:

The cause of the electrical failure was likely a high resistance in the supply from the buss. The resulting heat from the resistance most likely damaged the insulation of the conductors within the cabinet. Since there was no indication of arcing to compartment walls, a phase-to-phase short would have occurred and fuses destroyed. The resulting arc over would have over-pressurized the compartment with the flash. There were bulges in the door indicating overpressure. The shower of sparks would have ignited the plastic bag directly under the compartment.

We conclude that the energy in the resultant arc blast destroyed the wiring and fuses within the middle compartment, and ignited a bag of trash inadvertently placed against the metal cover of the lowest compartment. We conclude the source of the short circuit middle compartment was likely due to insulation damage from an overheating connection.

1. C-A Department should schedule preventive maintenance (PM) on all the MCC compartments in programmatic critical facilities.
2. C-A Department should develop a procedure, which is based on NFPA 70B and similar documents mentioned in the references section of this report, and set up PM tasks for electrical distribution equipment. Following procedure development, C-A Department should review its facilities and schedule PM for all its programmatic electrical distribution equipment.

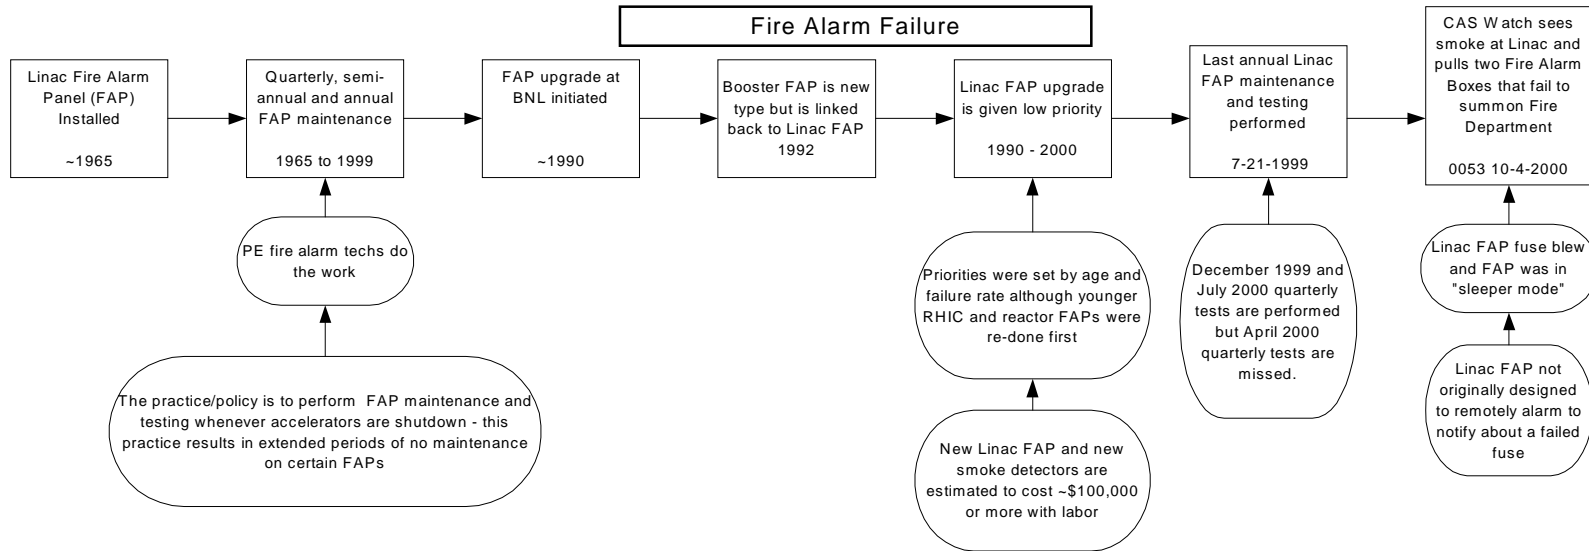
Fire Alarm Failure

A 2-amp fuse blew on the fire alarm panel (930-FAP150). The cause of the blown fuse is not clear. It may have been blown since the last time PM was performed, or blew coincident with this event. With this particular fuse blown, it puts the fire alarm panel in a "sleeper" mode. That is, for this type of failure, there is a loss of all AC and backup DC power to a portion of FAP150. This results in loss of both local and remote "trouble" indication to the Fire Department, and in addition, the local pull stations will not transmit signals to the Fire Department. A white local trouble light on FAP150 did work, but the associated panel buzzer failed or personnel entering the scene did not hear it. This type of failure is inherent in this particular fire alarm panel; a panel that dates back to about 1967. Similar fuse failures in FAP150 were not recorded during performance of previous PMs.

1. The BNL Deputy Director for Operations should reevaluate the Activity Data Sheet (ADS) identifying the need to upgrade approximately 60 fire alarm panels reported to be on-site with similar age and similar single-point failure design deficiency. The interim fix used at FAP150 to remote an alert on a failed blown 2-amp fuse solves only one of this panel's known design deficiencies, and FACP150 is reported to be different from other panels on-site.
